Manhole Inspection Summary

Manhole # S39U1_008MH

Insp Date: **6/18/08 10:00 AM**

Location Address: **200 Frankfurst Ave.**

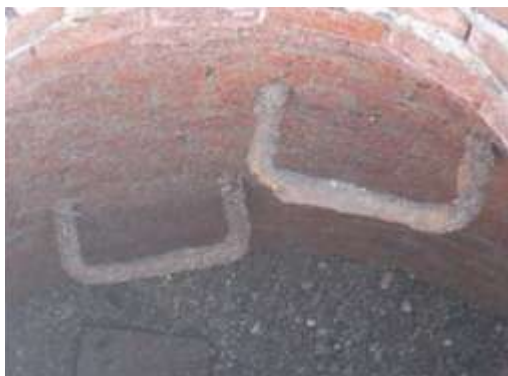
Steps Count: **2** Missing: **0** ☒ **Corroded**

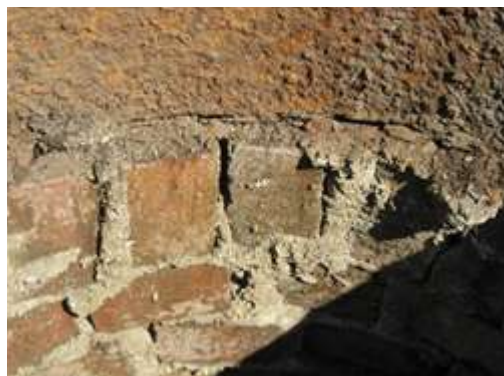
Defect 2

Condition: ☐ Sound ☒ **Cracked** ☐ Root Intrusion ☐ Loose Brick ☐ Deteriorated

Cracked Frame-Chimney Joint.

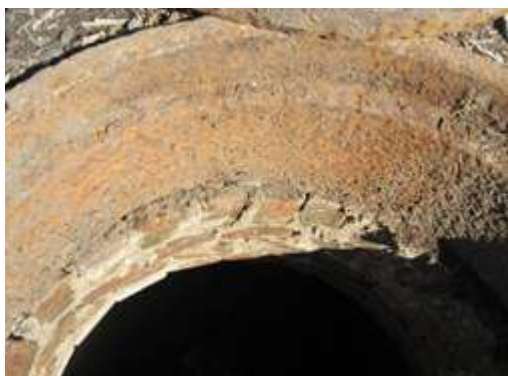
Defect 1

Frame Offset: **1** (in.) Condition: ☒ Sound ☐ Cracked ☐ Leaks

Frame offset

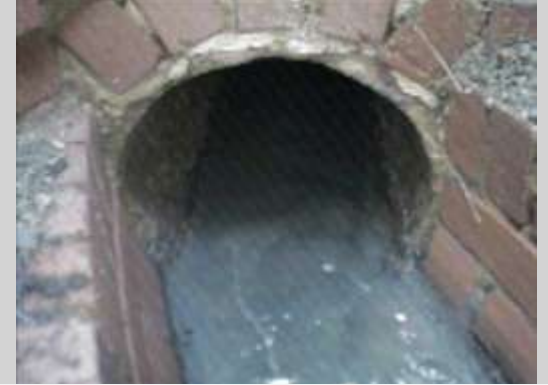
12 O'Clock Outflow

12 in. Circular Gravity Sewer
Pipe Out @ 12 O'Clock

Pipe Height: **12** (in.) Rod and Bar (Angled)
Pipe Material: **Clay** ☐ Pipe Lined
Invert Depth: **7.50** (ft.) Flow Characteristics: **Slow**
Deposits: ☒ None ☐ Mud ☐ Sludge ☐ Debris ☐ Grease
Silt Depth: (in.) Deposits Extent:
Infiltration: **None** Pipe Seal Cond: **Sound**

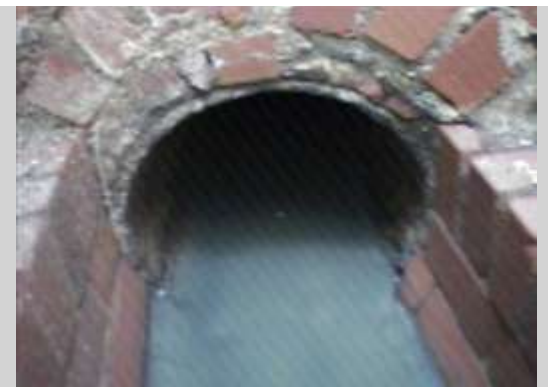
6 O'Clock Inflow

12 in. Circular Gravity Sewer
Pipe In @ 6 O'Clock

Pipe Height: **12** (in.) Rod and Bar (Angled)
Pipe Material: **Clay** ☐ Pipe Lined
Invert Depth: **7.42** (ft.) Flow Characteristics: **Slow**
Deposits: ☒ None ☐ Mud ☐ Sludge ☐ Debris ☐ Grease
Silt Depth: (in.) Deposits Extent:
Infiltration: **None** Pipe Seal Cond: **Sound**
